Monuments at Risk?

Mapping threats to heritage assets on the Malvern Hills: The British Camp Hillfort Survey

June 2015

Dr Jodie Lewis and Cat Lodge,
Institute of Science and the
Environment,
University of Worcester

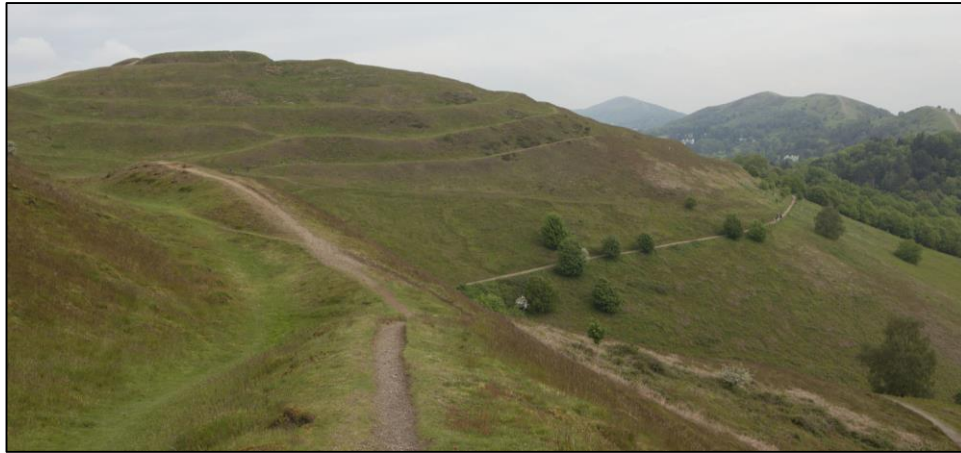
lead to significant damage and erosion of archaeological deposits as well as alterations to the profiles and setting of the earthworks (figures 18-20).

Figure 19: Footpath along rampart looking towards British Camp

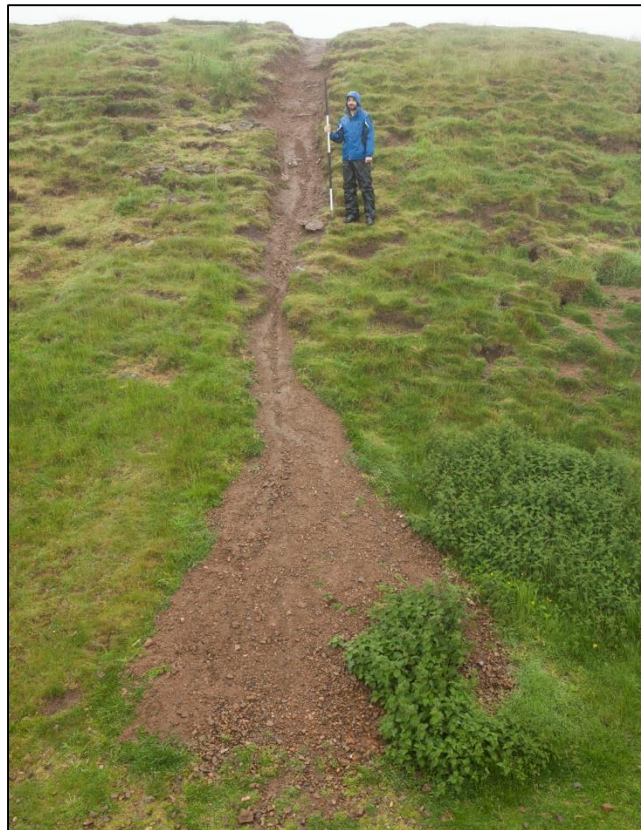
Figure 20: Damage to upper rampart through human erosion in the form of gulleys

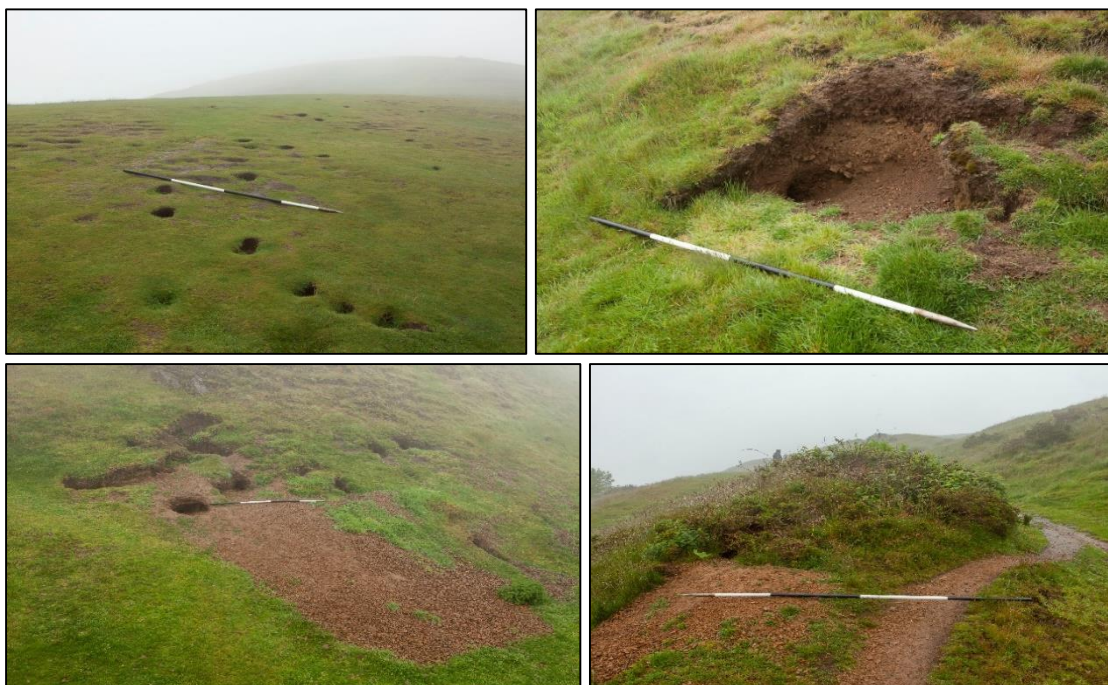
Rabbit burrows are concentrated on the eastern side of the monument (figure 10), and scattered rabbit damage is also most evident on the eastern side (figure 11). Intensive rabbit damage, such as shown in the top right and bottom left photographs in figure 21, is most obvious on the summit and eastern side of Herefordshire Beacon on the slopes of the ramparts (figure 12). Dorling highlighted one main area of rabbit damage on the south-eastern side of Herefordshire Beacon and also indicated that there were other less significant areas of damage across the rest of the monument. It would appear when comparing figures 7 and 13 that more damage has been caused as a result of rabbit activity, especially to the north-east of the monument.

Figure 21: Array of areas of rabbit damage on various parts of the monument

Efforts to control the rabbit population took place prior to 1998 through the utilisation of ferrets and blocking of rabbit holes (Alma 1998), and again in 2013/14 (Dorling 2013).

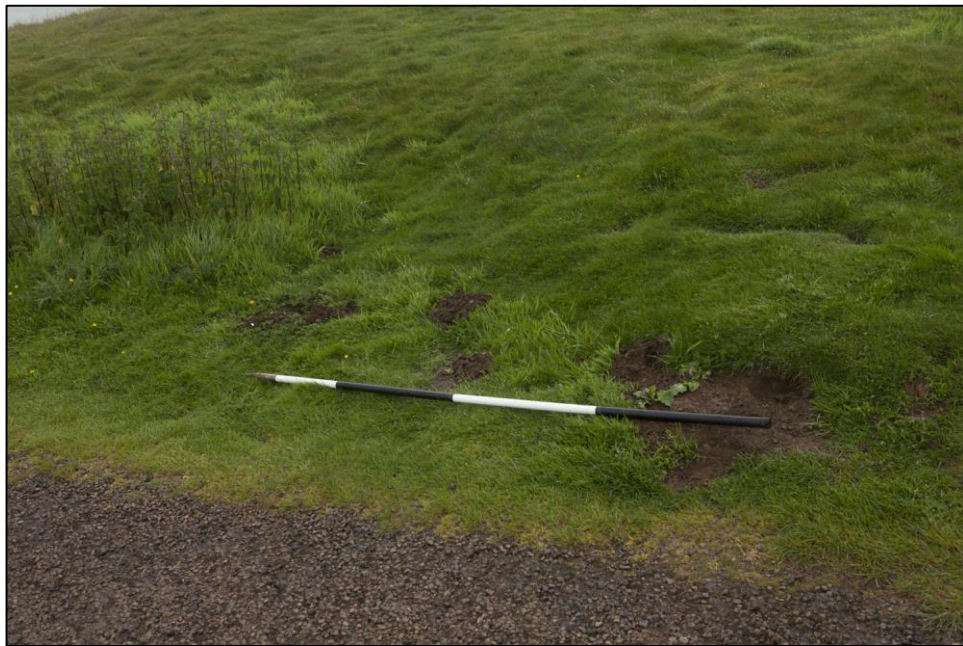
Figure 9 illustrates the areas of molehills recorded, and it is apparent that the majority of resultant damage from this category is to the north east of the ringwork of British Camp. The molehills appear to run parallel to the main footpath from the car park (figure 22).

Figure 22: Evidence of mole activity along path

The burrowing animals on British Camp have the potential to destabilise the earthworks leading to exposure of the soil and further degradation from influences such as the wind and the rain (Rimmington 2004). Evidence from other monuments would suggest the earthworks on British Camp, which have a slope greater than 20%, are particularly susceptible to this type of erosion.

Further considerations for study might include the detailed mapping of the entrenchment of paths or routes caused by recreational pedestrian and cycle traffic, the spread of rosebay willowherb onto cleared areas, and assessment of the maturity of vegetation. The research undertaken for this study has also noted the emerging activity of moles which may become a future threat and may benefit from monitoring.

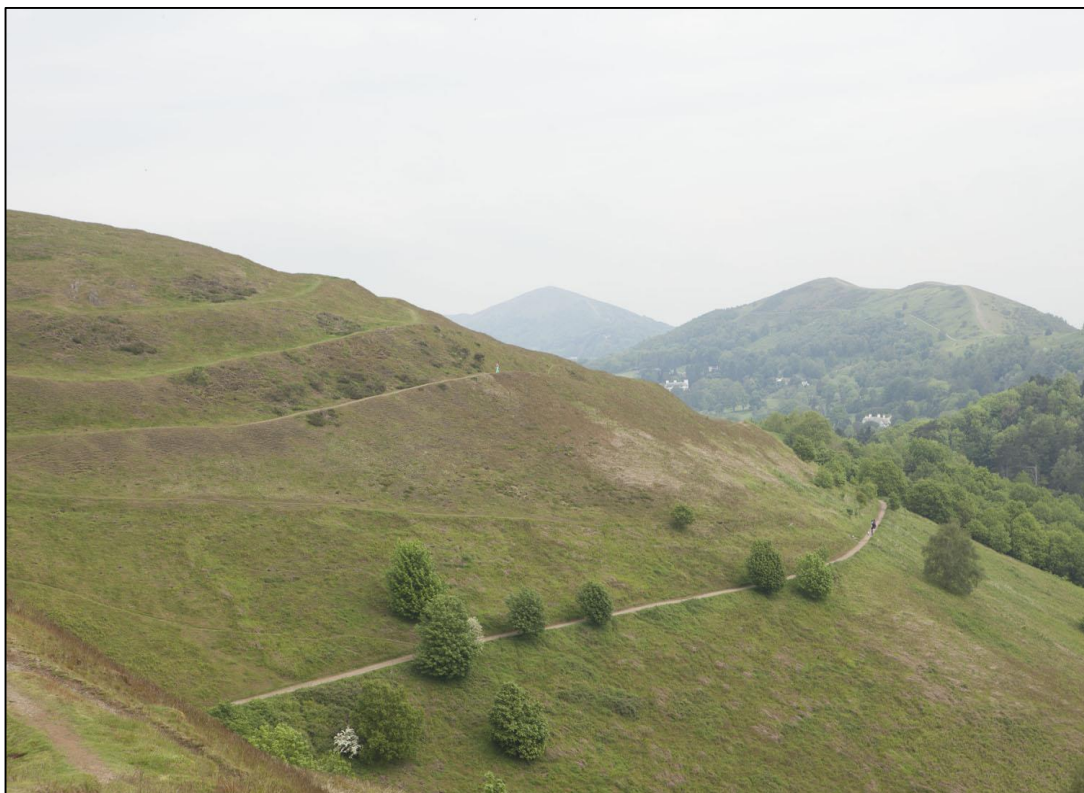
A number of isolated trees were recorded within the study area, and these are mostly located on the lower reaches of the eastern side of the monument (figures 14 and 23). Figure 30 in the appendix highlights the areas of denser tree cover, which in comparison is on the western side and extends down over the slopes.

Figure 23: Isolated trees along eastern side of Herefordshire Beacon

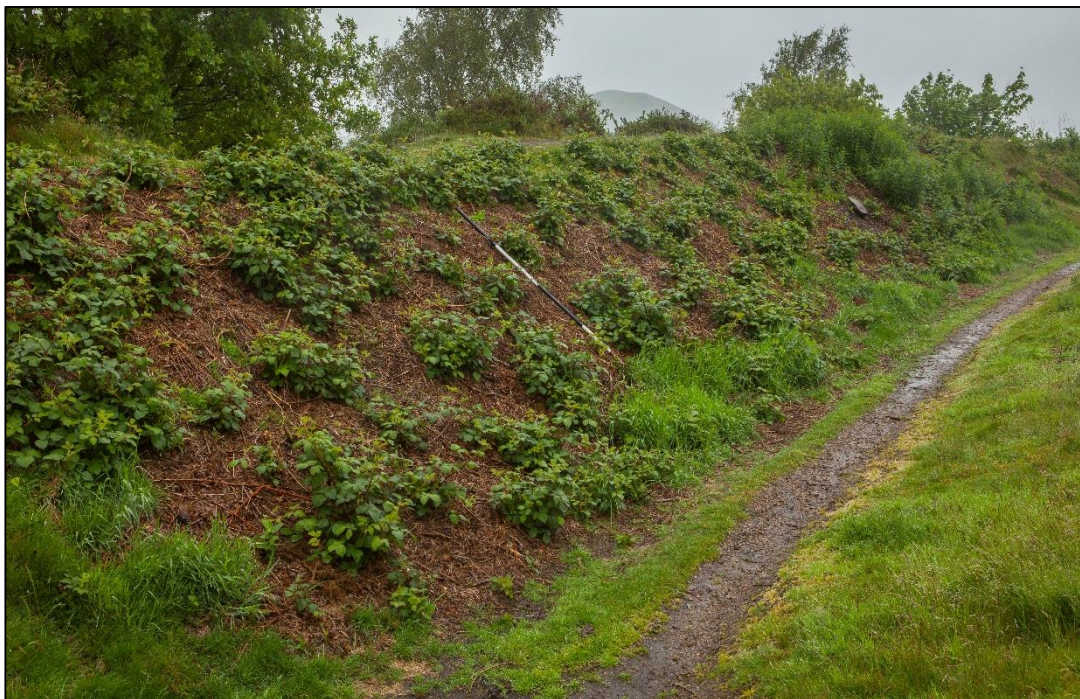
Bramble and gorse are two other forms of vegetation that are prevalent across the monument. Bramble is more concentrated around the western side along the lower ramparts, with small pockets on the eastern side (figures 24 & 27). Gorse is evident in almost exactly the same locations as bramble, but extends further up the slopes, and is more abundant on Millennium Hill than the bramble (figures 25 & 28).

Figure 24: Area of brambles on lower rampart on the west of the monument

Both bramble and gorse have the potential to affect the visibility of the monument, encourage rabbit activity and damage archaeology through root disturbance (Rimington 2004).

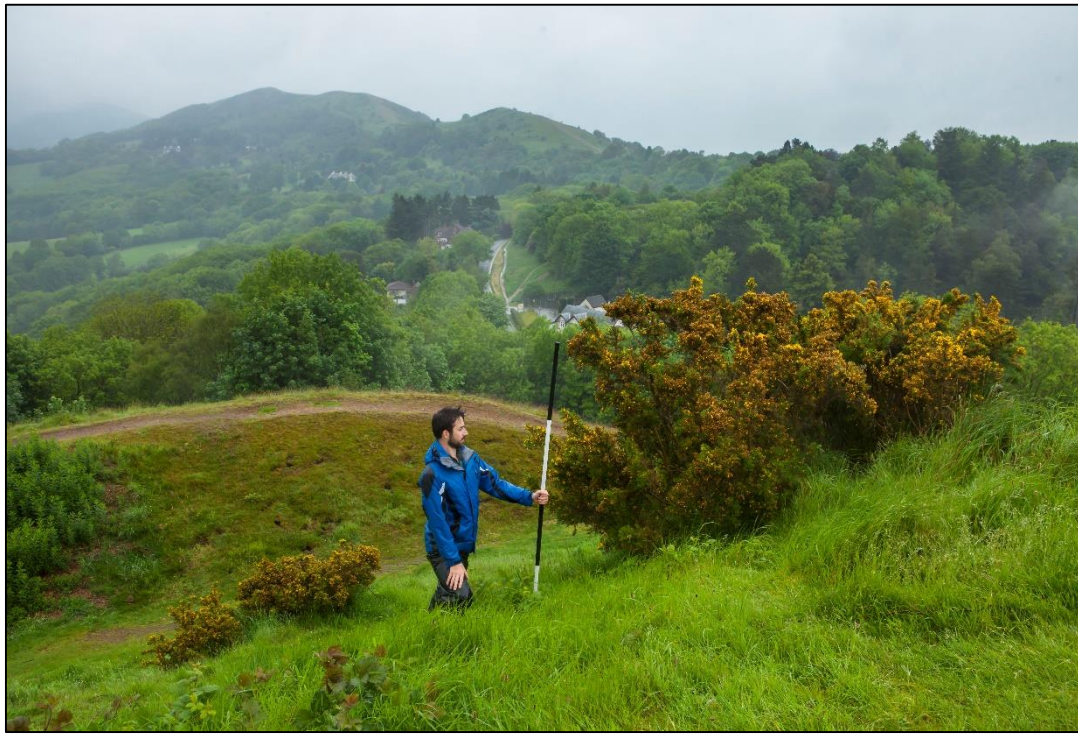
Figure 25: Area of gorse being recorded by students in May 2014

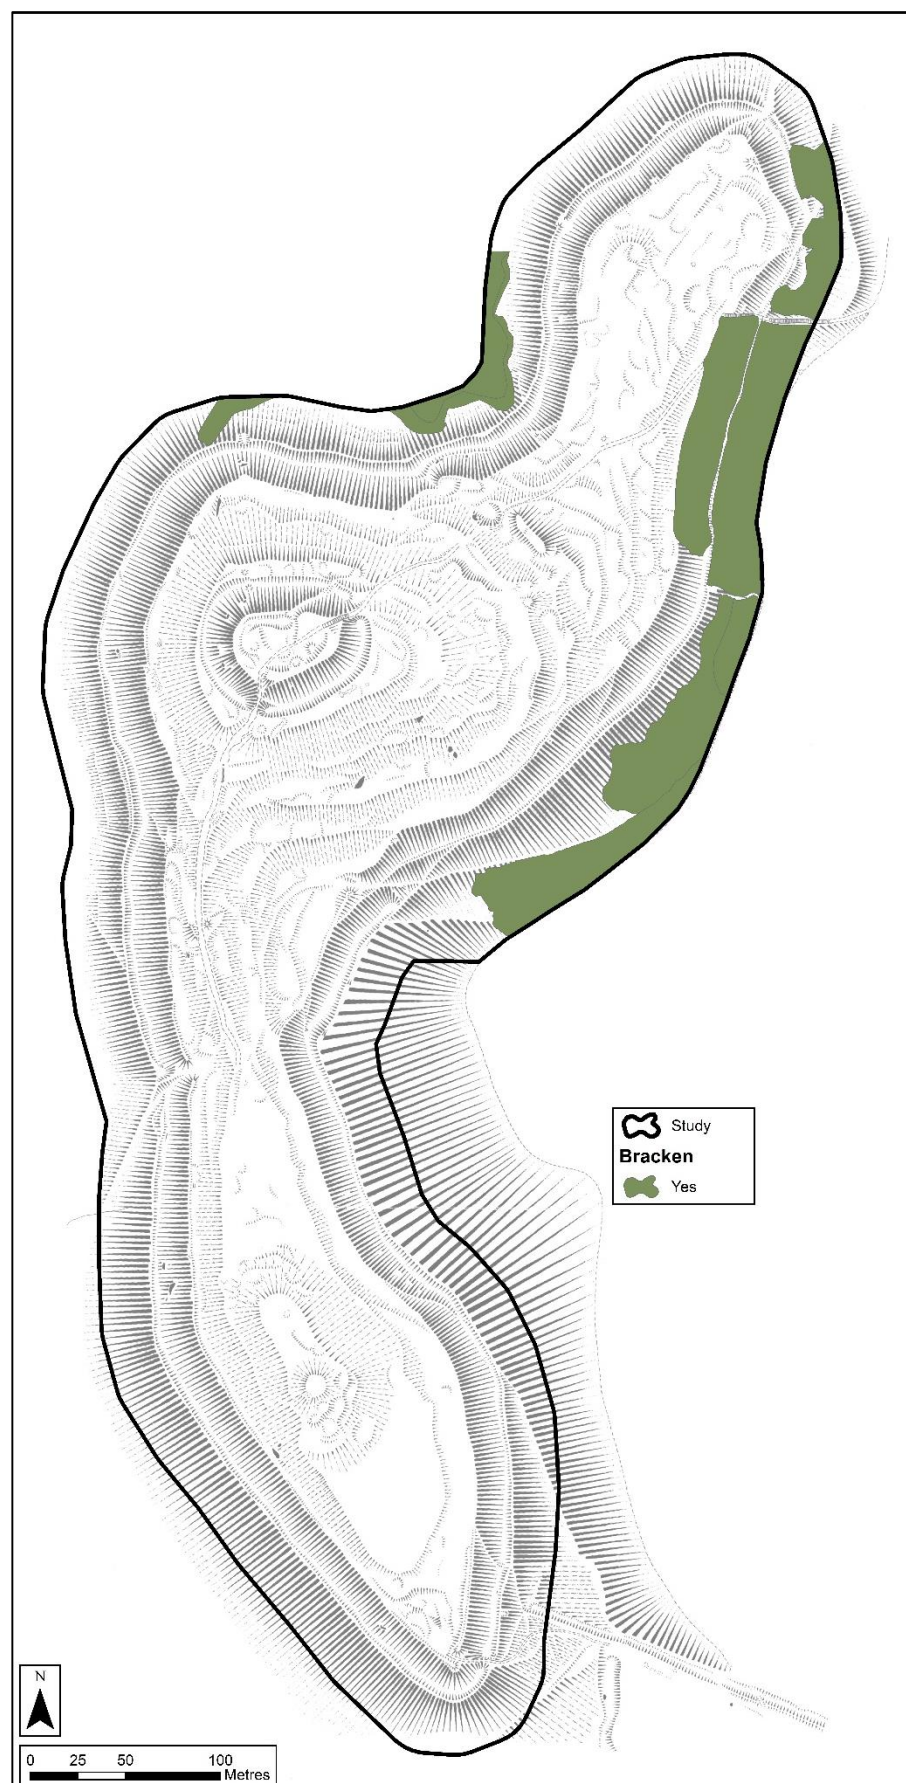
Bracken is concentrated on the northern side of the monument, along the lower ramparts (figure 26). Certain species of vegetation, in particular bracken, are a source of cover for rabbits (Dorling 2013). The control of bracken may need to be undertaken to prevent the risk of further damage in the areas where vegetation and rabbit activity are present. Bracken itself can be damaging to the long-term preservation of archaeological sites and may have a detrimental effect on the survival of archaeological remains (Rimington 2004).

**Figure 26:** Areas of bracken cover

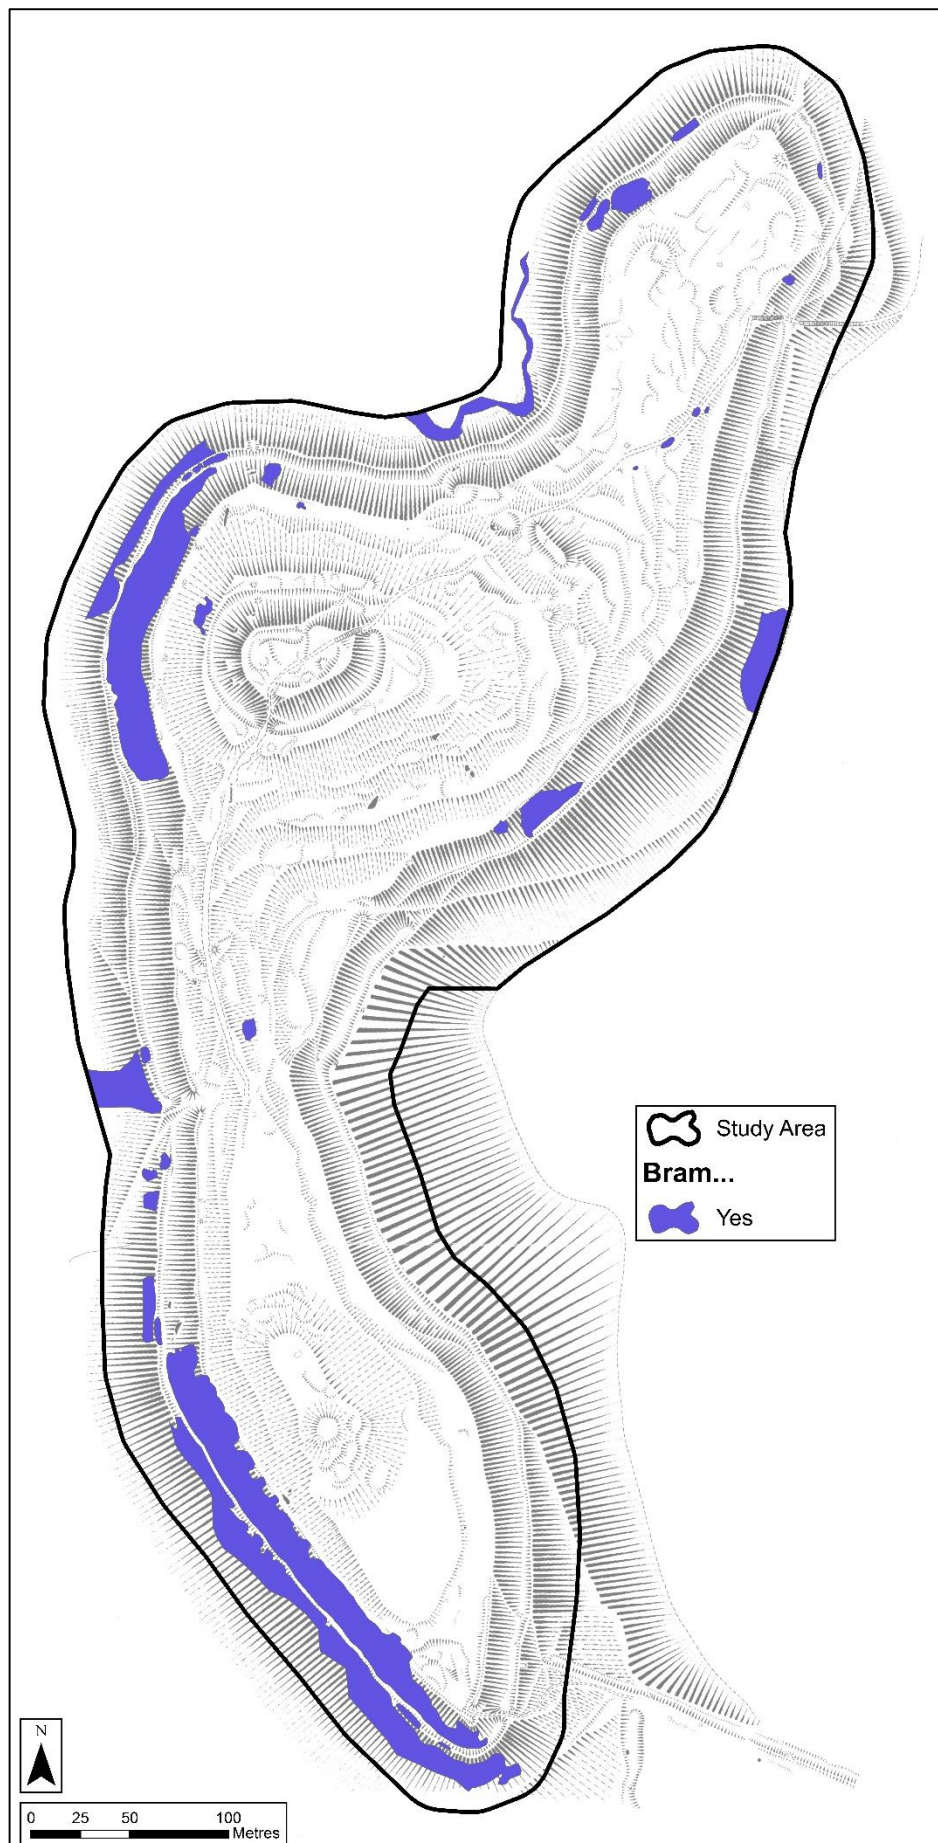
**Figure 27: Areas of brambles**

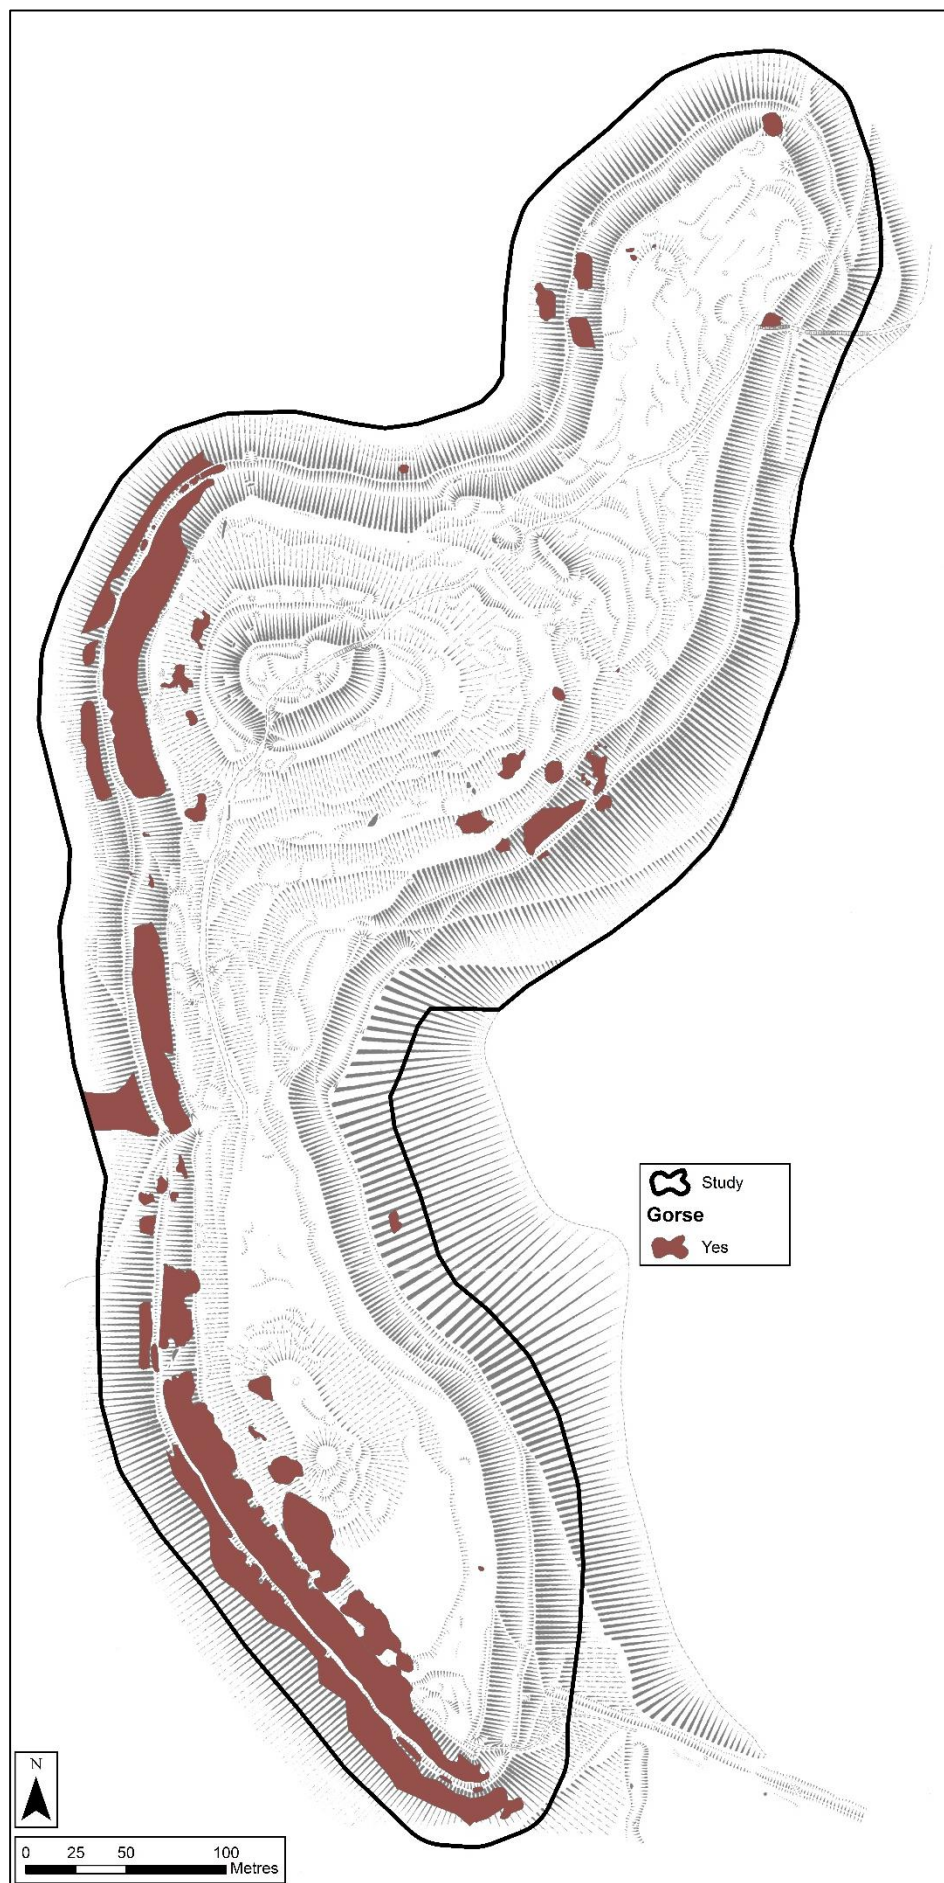
**Figure 28: Areas of gorse**

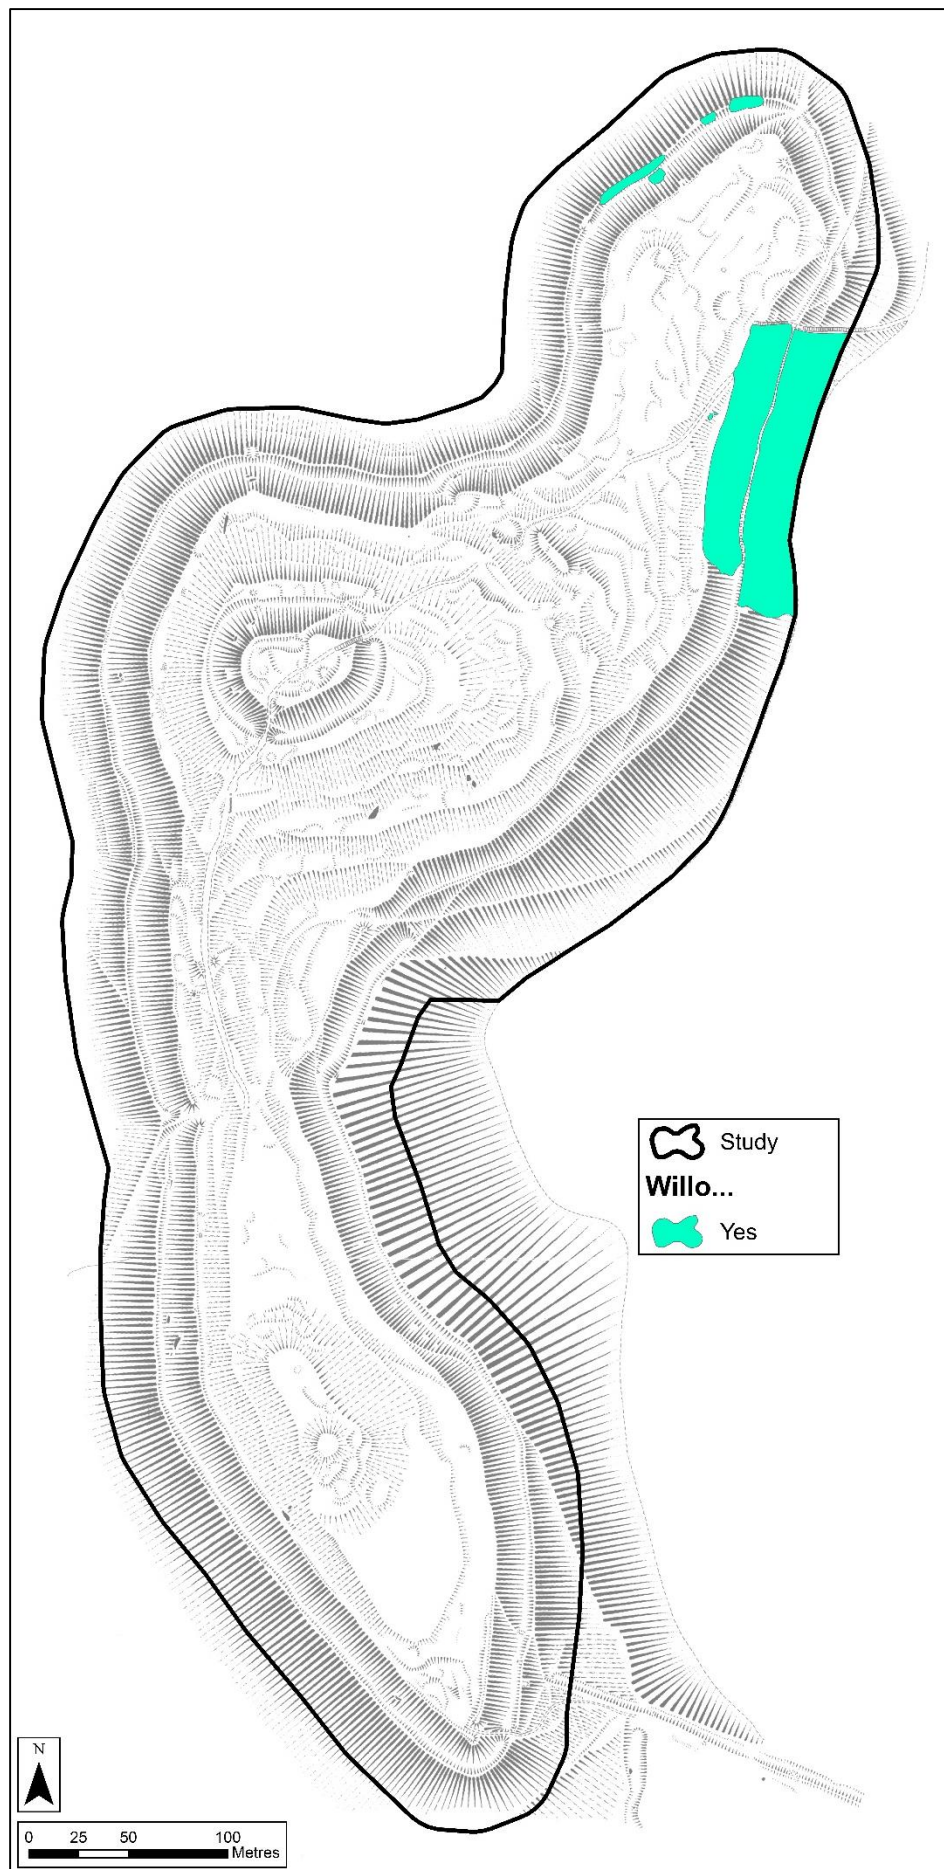
Rosebay Willowherb appears to be concentrated along the north-eastern side of the study area, with a small area to the north-west (figure 29). This type of plant is invasive, and like the other forms of vegetation in this report may cause damage to the integrity of the archaeological deposits within this area.

Figure 29: Areas of Rosebay Willowherb

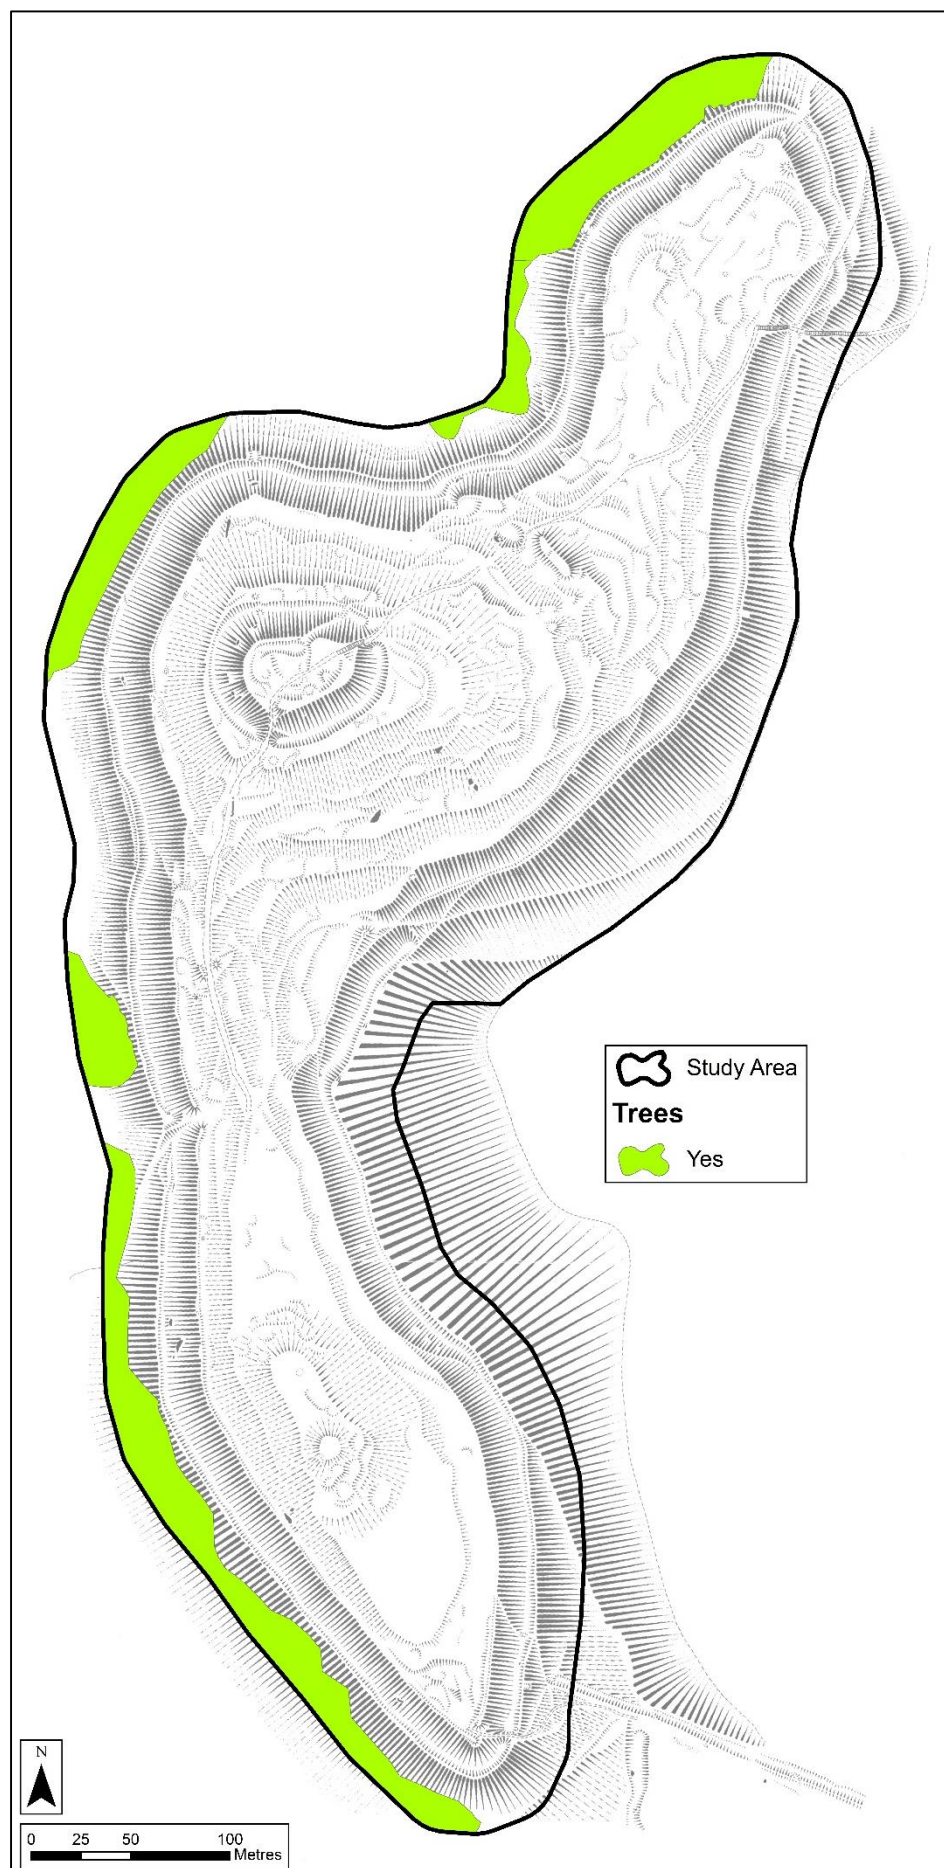
**Figure 30: Tree cover**

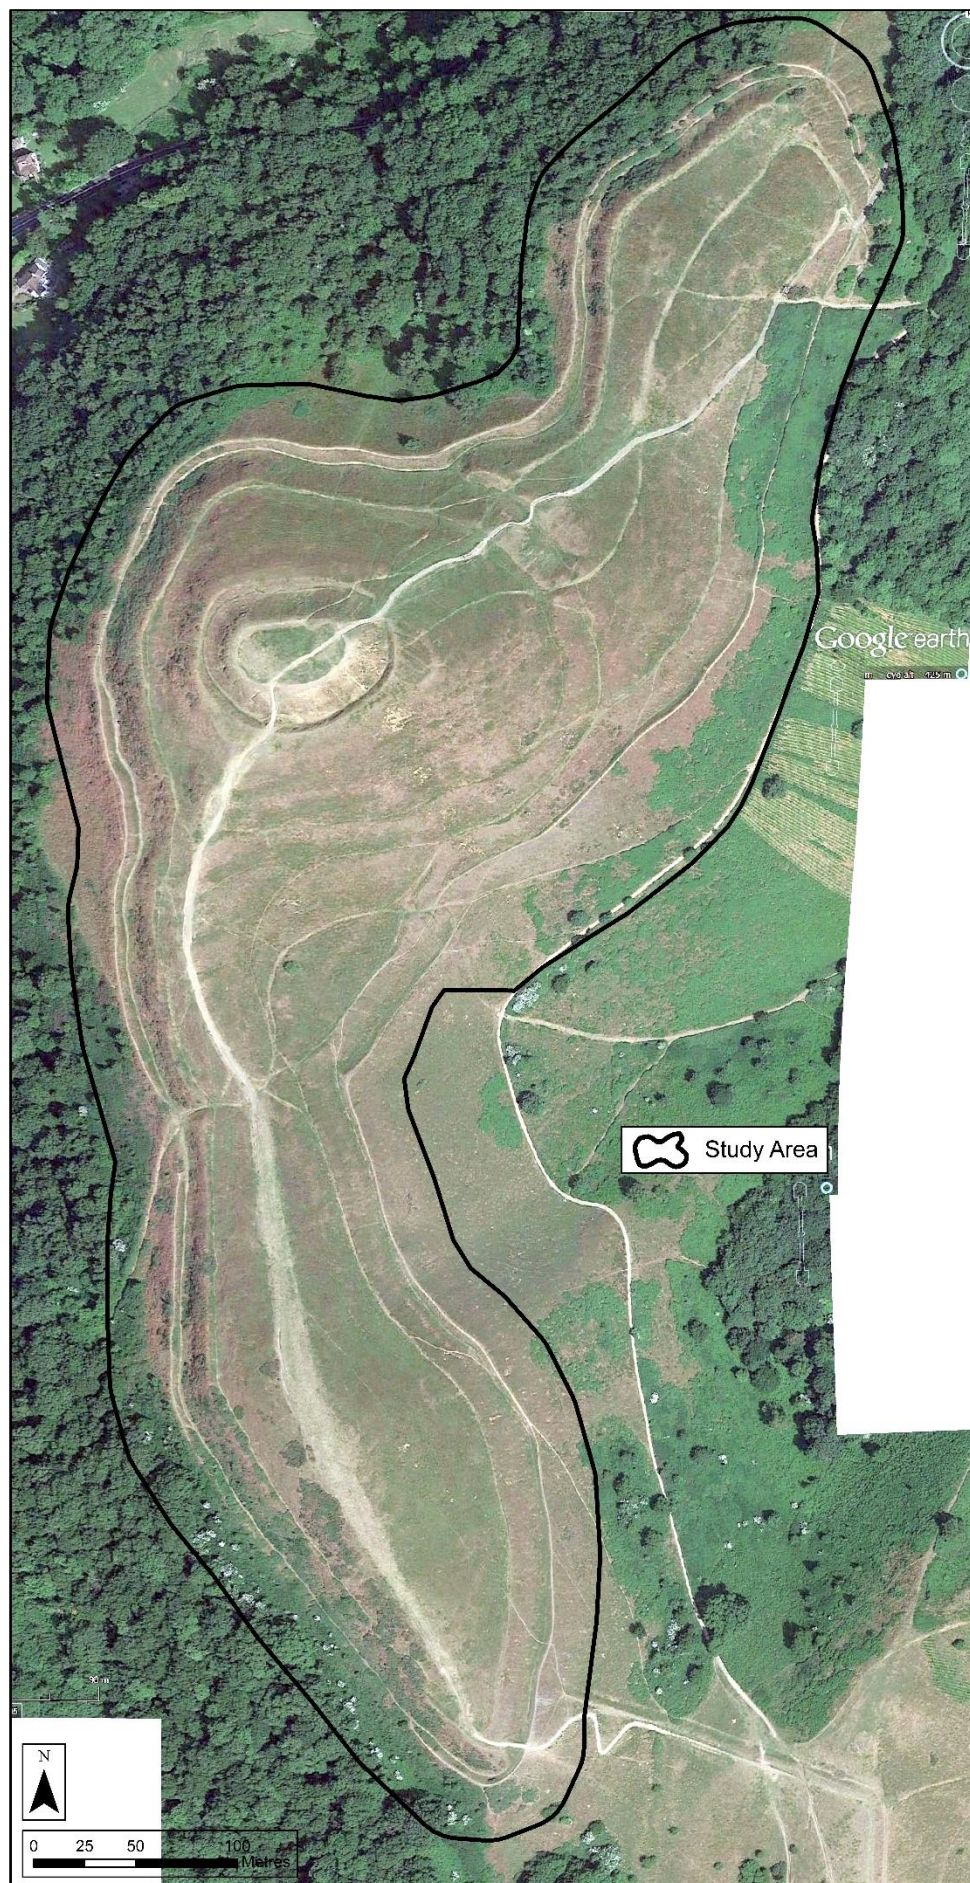
The following section provides detailed maps of the GPS survey results, as defined in the methodology. Each threat is mapped individually, as well as composite figures for rabbit damage and vegetation. A final composite map showing all areas of damage and threat to the monument is also included. Figure 31 in the appendix is a Google Earth image of the study area which also clearly shows the different vegetation and erosion.

Figure 31: Google Earth image of study area
